MERRIMACK RIVER BASIN  
BERLIN, MASSACHUSETTS

LESTER G. ROSS DAM  
MA 01229

# PHASE I INSPECTION REPORT NATIONAL DAM INSPECTION PROGRAM

JUNE 1981

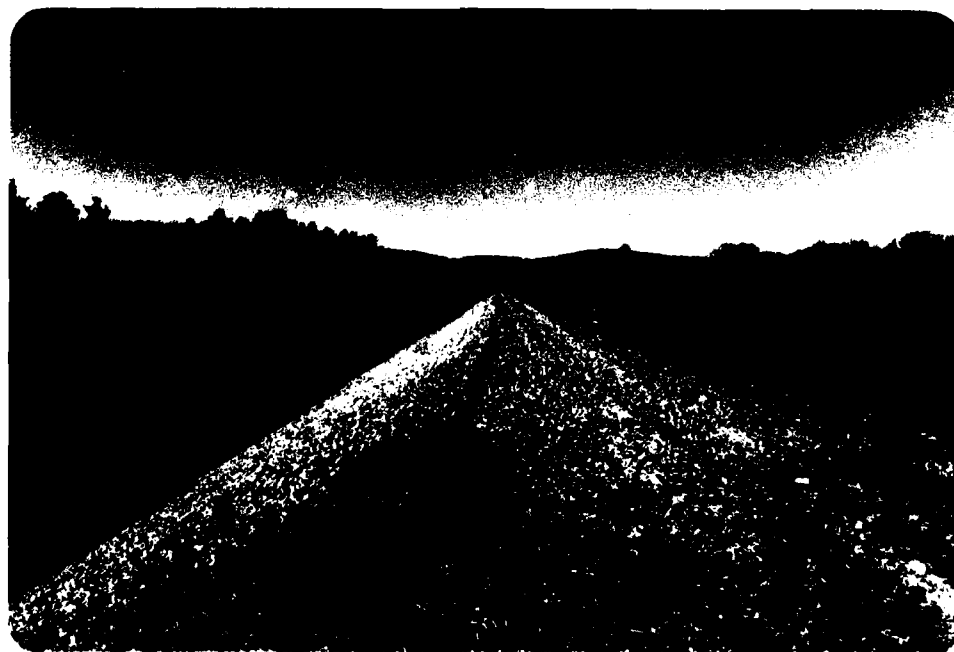
NO. 4 CREST AND DOWNSTREAM SLOPE OF DIKE

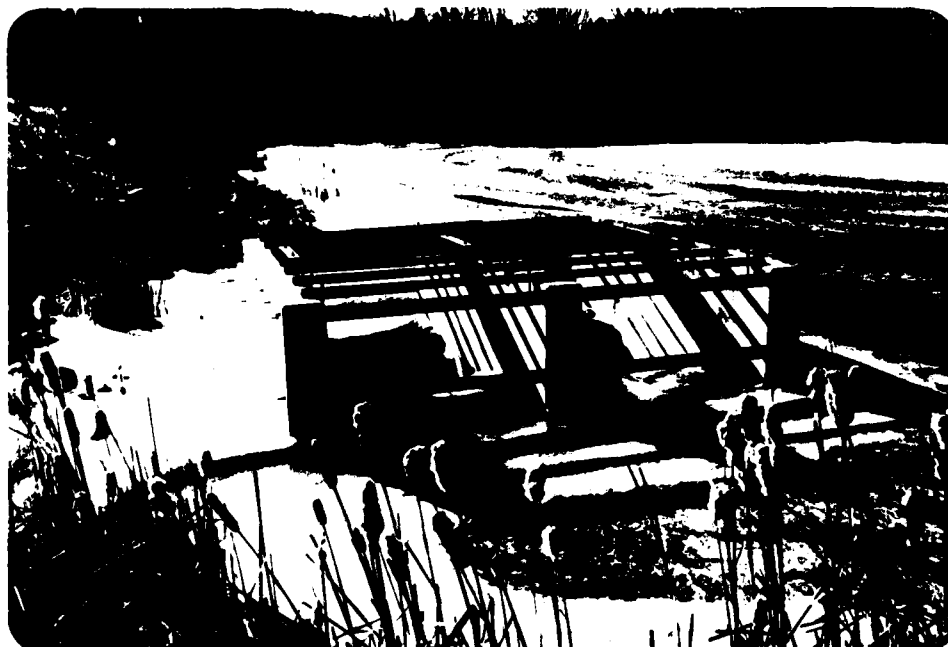
The concrete on the inlet and riser is in good condition. There are some minor chips which are generally due to vandalism. Two large pieces of riprap had been dropped into the structure. One was caught in a slot in the left wall of the riser. The other was lodged in the entrance to the discharge conduit. The conduit was also chipped. There was no other debris visible in the main spillway structure.

a. Approach Channel	
Slope Conditions	Submerged
Bottom Conditions	--
Rock Slides or Falls	--
Log Boom	Steel trash rack in upper and lower stages of riser-good condition.
Debris	One boulder caught in slot in left wall of riser. One boulder caught in entrance to outlet conduit.
Condition of Concrete Lining	--
Drains or Weep Holes	--

b. Intake Structure	--
Condition of Concrete	Good condition; slight staining below waterline, minor chips, probably due to vandalism.
Stop Logs and Slots	Submerged - 20 wooden stoplogs installed at u/s end of inlet structure.

NO. 6      DROP INLET STRUCTURE

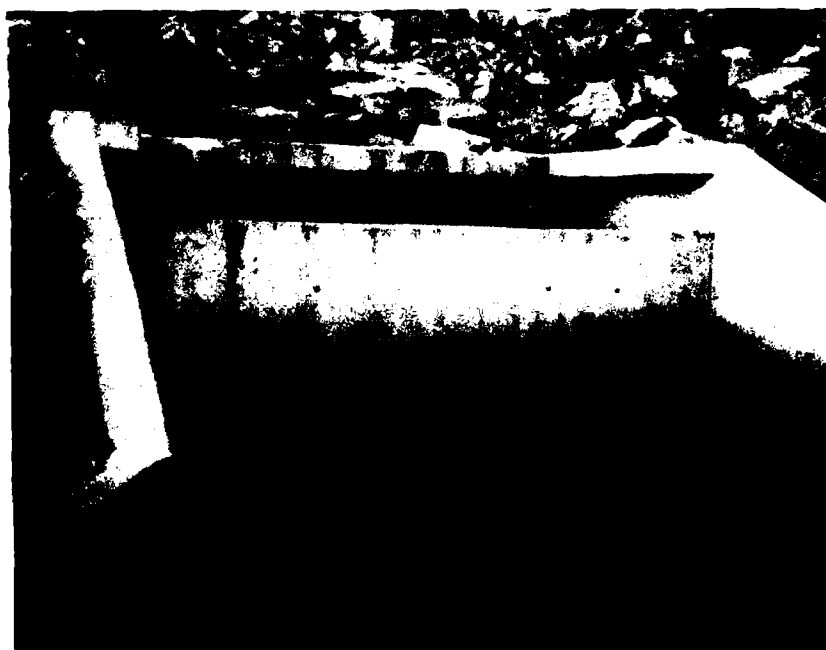
The concrete impact basin at the downstream end of the dam is in good condition, with only minor chips in the concrete, most of which had already been patched. A moderate amount of flow was discharging into the basin at the time of the inspection. The outlets to the foundation drains were submerged. The basin was clear of brush and debris, however, a small obstruction consisting of riprap blocks had been built by vandals just downstream of the basin, obstructing flow in the channel.

AREA EVALUATED	CONDITION
OUTLET WORKS - OUTLET STRUCTURE AND OUTLET CHANNEL	RC impact basin at discharge end of principal spillway. Good condition.
General Condition of Concrete	
Rust or Staining	Minor-at and below water line.
Spalling	None
Erosion or Cavitation	Chipped by vandalism-boulders thrown into structure.
Visible Reinforcing	None visible.
Any Seepage or Efflorescence	None visible.
Condition at Joints	Good
Drain Holes	Weep holes at base of sidewalls (sub- merged). Also discharge ends of foundation drain.
Channel	Unlined channel beyond concrete im- pact basin.
Loose Rock or Trees Over- hanging Channel	Some brush, no trees or rocks.
Condition of Discharge Channel	Fair-small "dam" has been construc- ted across channel, using riprap blocks. This should be removed.

NO. 8    DETAIL OF IMPACT BASIN AT OUTLET DISCHARGE

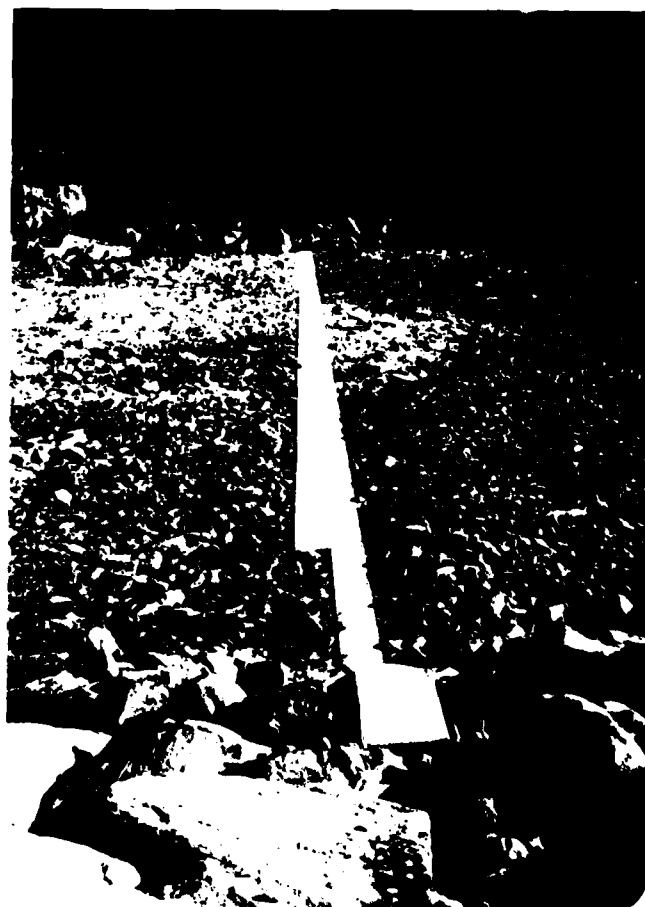
b. Weir and Training Walls	
General Condition of Concrete	NO walls-left bank is rock cliff. Earth embankment & rock waste dike adjacent to left abutment of dam. RC weir anchored to bedrock, in good condition.
Rust or Staining	None visible.
Spalling	None
Any Visible Reinforcing	None
Any Seepage or Efflorescence	None visible.
Drain Holes	Spillway drain at toe of bedrock cliff. Drains into reservoir at NW end, through 6" C. M. pipe (slightly rusted, no flow)

**NO. 12 WEIR ON EMERGENCY SPILLWAY**
